THE LANDSCAPED SPACE OF HISTORIC CENTER OF AIZPUTE

Una Īle, Aija Ziemeļniece

*Latvia University of Life Sciences and Tehnology, Faculty of Environment and Civil Engineering,
Department of Landscape Architecture and Planning*

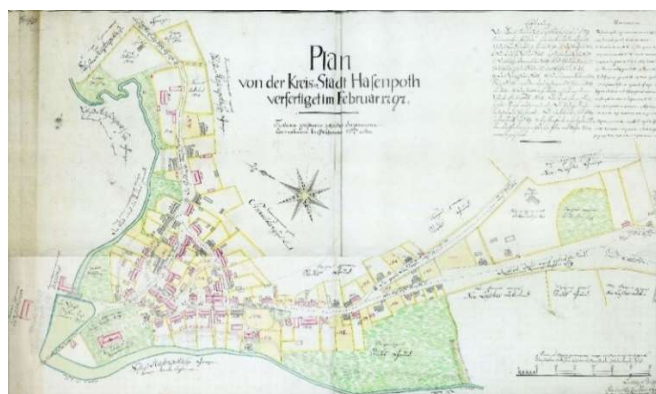
Figure 1. Plan of Aizpute town, 1797 (Source: Museum of Culture Heritage of Aizpute)

The map from 1797 is the first historic evidence of the increased water level of the river Tebra and the layout of the town's green structure. It is possible to detect the high building density of the town's central part in the map (Fig. 1).

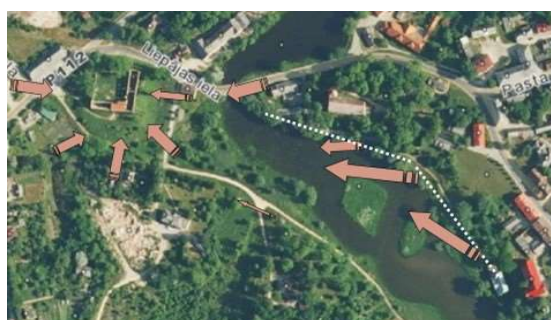
Figure 3. Sight lines in the direction of the Livonian castle (Source: authors' scheme)

The old castle has lost the external form of its historic size in the course of the centuries. Specifically it refers to the south side. The remains of the castle clearly outline the scale of the inner yard, the height of the building, the slope of the Tebra left bank as well as a perimatal slope which is adjusted to the castle. The slope is obvious also in the east and west part of the castle. Thus viewing points to the fortress of the castle are located in a vast landscape. The most expressive are the sight lines in the south part from the Tebra's right bank or Pils street, in the east part - it is the sight from the mill lake (Fig. 3). Liepāja street which serves as the main traffic road visually ends in the western part with the castle size on the hill forming a dominant point of the street. Liepāja street curving around the north side of the castle

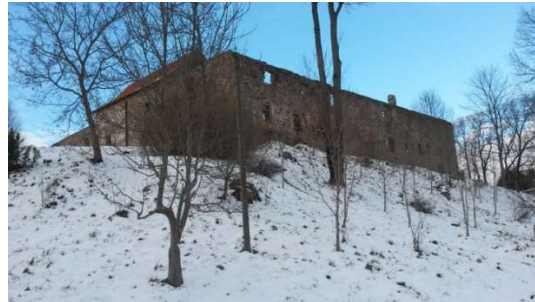
Figure 4. The growth on the castle mound (Source: authors' photo, 2016)

The thinning of the south east slope during the last ten years is a positive example of eliminating clump and the influence of maintenance on the visibility and highlighting of culture objects. However, it is necessary to consider the elimination of many of the remaining trees. The south west side of the slope (in the angles from Krasta street) is covered with intensive growth of trees. The sight lines on the old castle from Liepaja street at the historic stone bridge are partly covered with a two-storied living building, which was built at the beginning of the 20th century. The barns for wood are located there. Since the technical condition of the building is not satisfactory, the local government has to make a decision regarding leaving this house or not in the zone of the castle's slope (Fig. 5, 6). The castle mound with the fortress historically had the purpose of noticing the enemies from its top, therefore sight line could not have been covered by anything. Therefore the restoration of the castle means not only the recovery of its historic size, but also restoration of the true outside space. The above mentioned research regarding the landscape space of Livonian castle serves as the preparation or a matrix for the study of other objects that are located around the Tebra mill lake.

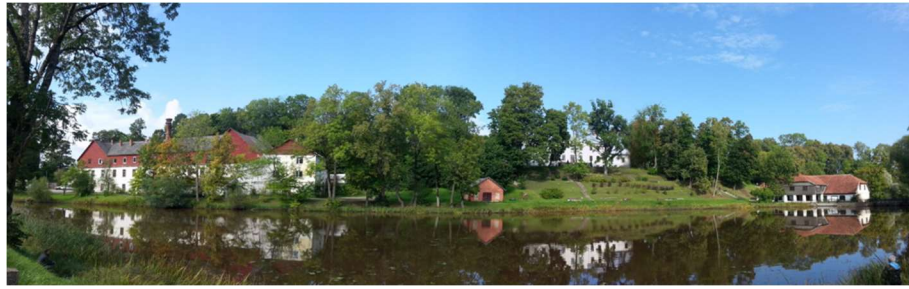
Figure 7. The sight line to the brewery, the master's house and water mill (Source: Spāģe, 2017)

The second dominating point of the north shore of the mill lake from Liepaja street is the manor's main building with adjacent houses (Fig.7). Similarly to the Livonian castle, the manor buildings are located on the steep slope of the mill lake which is created in several levels. The facade of the manor's main building or the master's house has lost the central rizalite with columns typical of the classicism style thus diminishing the stylistic expressiveness of the building (Silārs and Sants, 2014). The main sight lines in the direction of the owners' house are located on the south shore of the lake in Liepaja street. At present the house is hidden in the overgrown trees and it is difficult to perceive it in summer. The scrubland of the shore's slope formed from seeded trees and bushes has altered the scale of the landscape space of the shore and sight lines in the course of time. It refers to viewpoints in both directions. The terraced slope's inclination of the main facade of the owner's house is the most picturesque landscape element of the mill lake. The sunny side of the slope and the scale of the building create a compositionally strong and harmonious play. Similarly to the previously mentioned Livonian castle, it is necessary to recover the expressiveness of the historic sight lines as well.

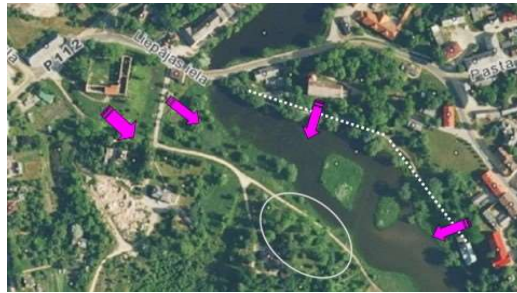
Figure 8. Sight lines to Baznickalns hill (Source: authors' scheme)

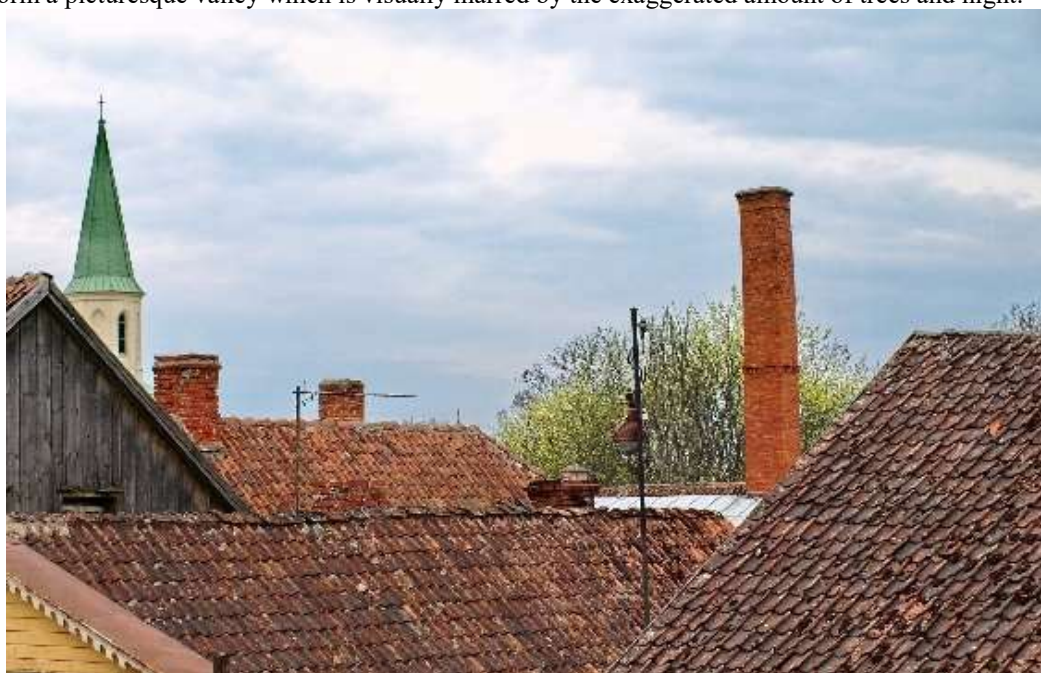
Figure 15. The landscape of red tile roofs. Kuldīga (Source: Kuldīgas municipality, 2013)
